Flight Summary: WB-57F MidCiX – 30 April 2004

Purpose of Mission: Sample cirrus under EOS Terra satellite.

Flight description – Flight #5, MidCiX mission, Terra validation in cirrus

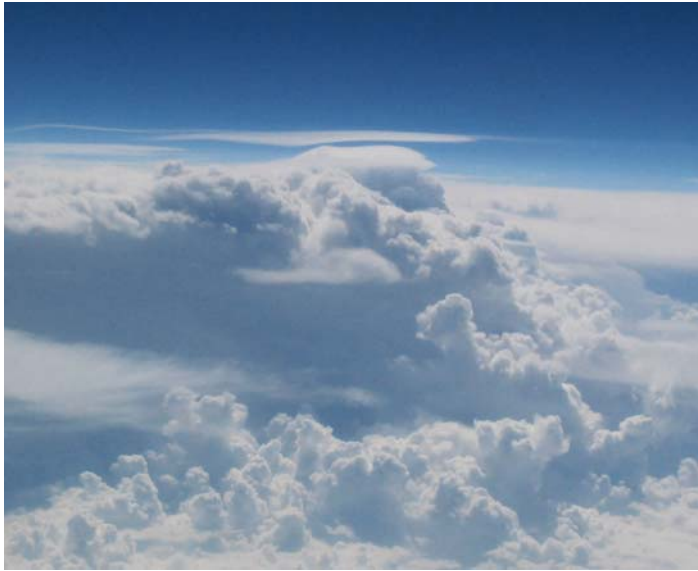
Top: Cirrus layers observed above a cumulonimbus cell early in the flight. Bottom: Halo visible in the cirrus with cumulus below.

- At 15:10, we descend down to FL 410. At 15:15, a big storm cell was at about our 2 o'clock that had a tremendous amount of blow-off to the northwest. The main cell topped out about FL 430. The top of the cell cloud had a laminar "cobweb" of cloud covering it, and a thin wisp of cirrus directly over it, following the contour of the storm cell.
